Project Brief

Interstate 94 Overpasses

Column Repair

Southern Wisconsin
2002

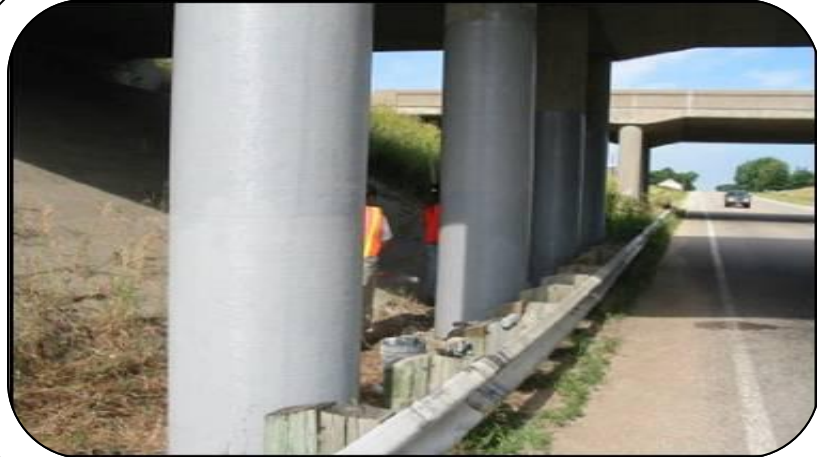
Several columns on numerous bridge overpasses showed signs of corrosion at the mid-height down to the base. The severe spalling and associated deteriorated reinforcement was mainly due to the close proximity of the columns to the busy Interstate. Constant splashing of snow and slush during the winter season enabled de-icing materials to deteriorate the concrete and reinforcement. The most severe corrosion was evident in the reinforcing ties.

Loose cover concrete was removed, and the existing concrete and rebar were treated with the Tyfo® Corrosive Inhibiting System. Tyfo® P Epoxy-Mortar patching material was then used to restore the original sections of the columns. Lastly, the columns were wrapped with the glass-based Tyfo® SEH-51 Composite System. The non-corrosive composite wrap provides future protection from de-icing infiltration and also provides confinement strengthening, replacing the ineffective, deteriorated tie reinforcement.
