Project Brief

ASU Steel Pipe Joint Repair

Phoenix, AZ
2009

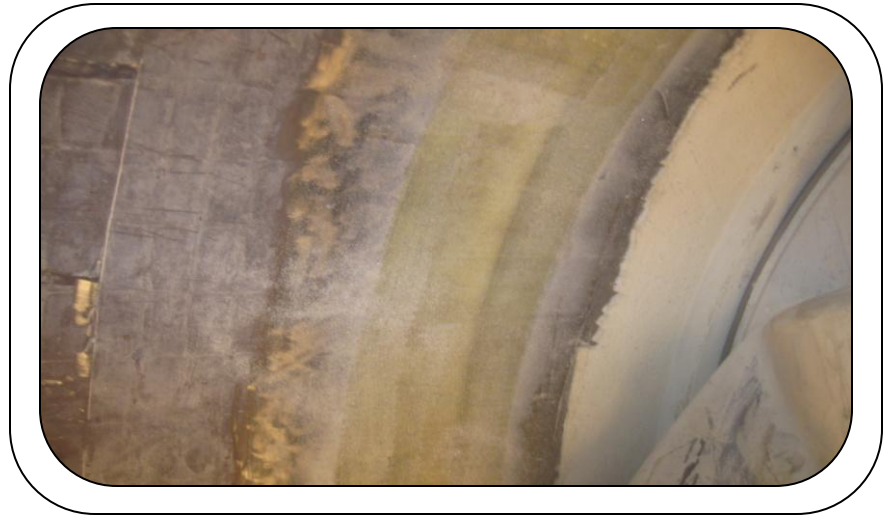
A 90-inch diameter steel pipeline in Phoenix, AZ contained a cast iron valve with a flange joint that is higher than the surface of the pipe and also exhibited leaks.

The mortar where the existing leak occurred was removed. A steel plate was then welded on with nuts at penetrations and the grout reinstalled.

Fibrwrap Construction then installed the Tyfo® SEH-51A System around the existing butterfly valve connection, and filled it with thickened Tyfo® S Epoxy to smoothen and level the uneven connection.
