FTC-002

Inspection Report

Twelve-Year Inspection of Tyfo[®]
Fibrwrap[®] System Applied in
Marine Environment

Report Prepared by Dr. Guijun Xian
August 18, 2008

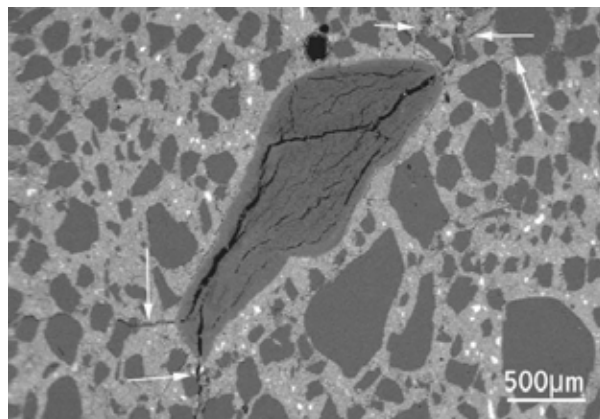
Figure 1⁴: Polished section of concrete, viewed with a scanning electron microscope, showing a chert aggregate particle with extensive internal cracks due to alkali-silica reaction. The cracks extend from the aggregate into the nearby concrete (arrowed).

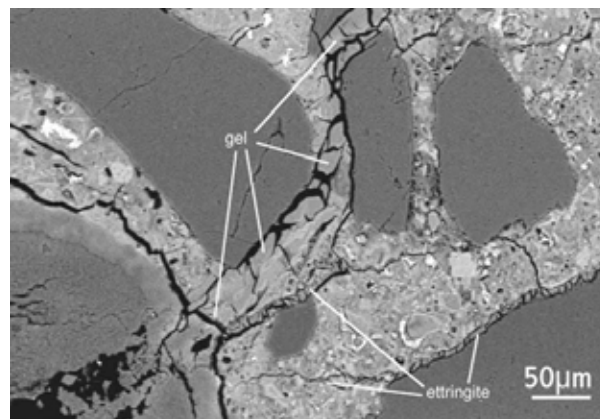
Figure 2⁴: Detail of the chert particle in the previous image and adjacent cement paste, showing alkali-silica gel extruded into cracks within the concrete. Ettringite is also present within some cracks.

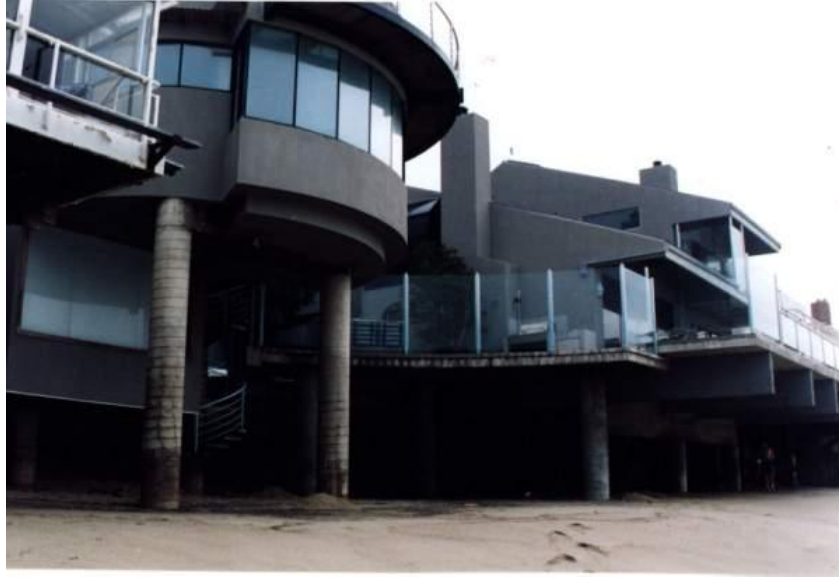
The ocean front residence building, located in Malibu, California, had been pounded by the surf over the years. The supporting columns and beams had been extensively damaged due to ASR. Columns suffered moderate to severe cracks and general spalling, which reflects the deteriorative effects of the ASR on the concrete. The photograph (see Figure 3), taken prior to the testing, shows the extensive cracks around the columns and the chinks of concrete, especially on the bottom of the column.

Figure 3: The ASR deteriorated concrete columns, with extensive cracks on the concrete surface and concrete chalking (on the bottom of the column).

The Tyfo Fibrwrap System was used to repair and strengthen the columns and beams. The first step in the repair process was to remove all degraded concrete. Then the exposed steel reinforcement was treated with Tyfo® CIS corrosion inhibitor to prevent future corrosion. It is worth noting that the safety of a concrete structure is considered not to be seriously compromised as long as the reinforcing steel is not broken due to ASR-caused expansion¹. After the treatment of the steel, Tyfo® products are used to patch the missing concrete and restore the column shape. Based on estimations of the loss of the steel reinforcement, engineers from Fyfe Co. designed the Tyfo® Fibrwrap System to add the necessary strength to replace flexural, shear and confinement deficiencies. A Tyfo ® coating in white was applied to finish the FRP surface. The finish coatings are to protect the Tyfo® FRP system from the abrasive nature of ocean tides, sand, sun irradiation etc.

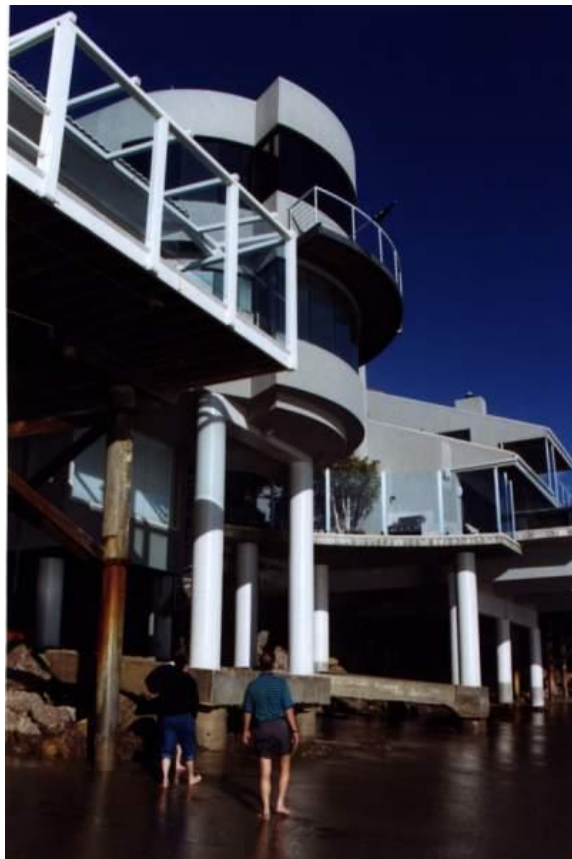
Figure 4: Columns retrofitted with Tyfo® Fibrwrap® System.

It is worth noting that the bottom column was seriously damaged with concrete chalking due to the ASR before retrofitting (see in Figure 4). After 12-years of service in sea water and high humidity, the column retrofitted with Tyfo[®] Fibrwrap[®] System retains its structural

integrity, without any cracks or deformation on the surfaces. This indicates that there is no further propagation of the ASR.

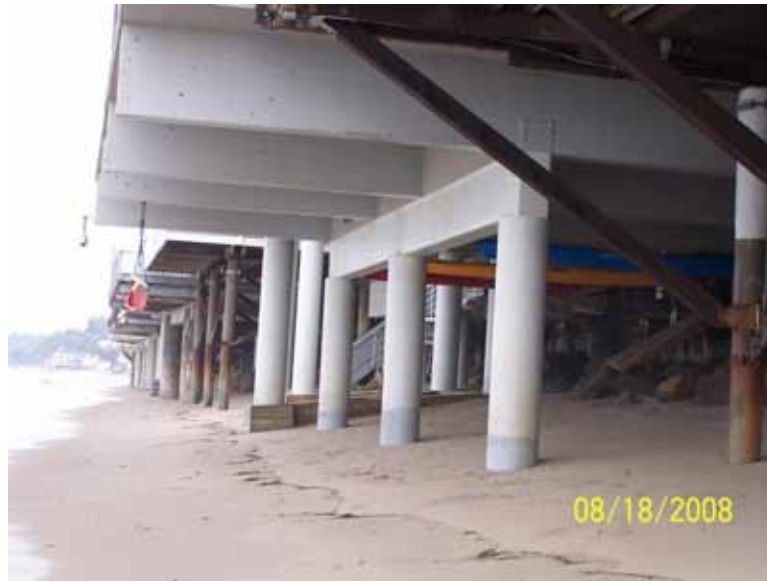
The retrofitted columns and beams, 12-years after FRP application, are shown in [Figure 5](#). There are no signs of debonding, cracks or any irregular deformations, which indicate the Tyfo® Fibrwrap® System is effectively preventing the concrete structure from further damage from ASR.

Figure 5: The retrofitted columns and beams on August 18, 2008.

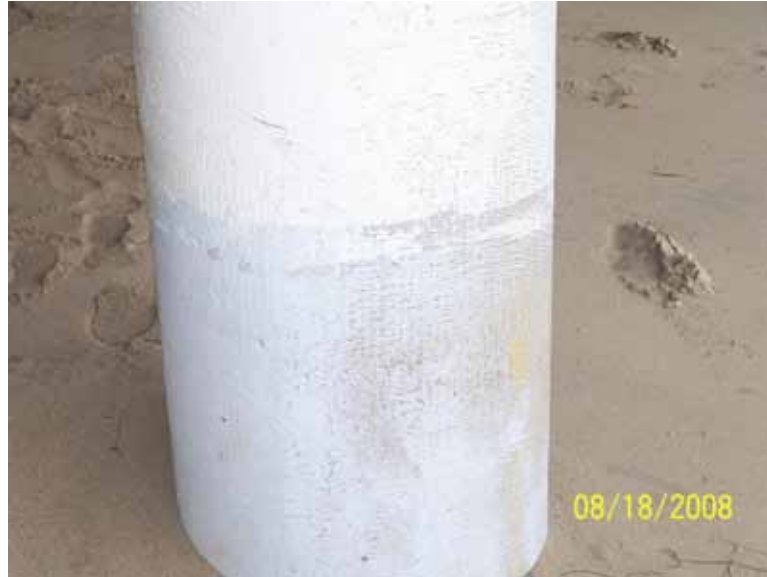
All columns are in perfect condition. No delaminations, blisters or any signs of degradation were found along the whole column. Due to the long-term wearing effects of the sea water with sand, on the bottom of columns in the area facing the sea, some coating was worn out as shown in [Figure 6](#). As shown in [Figure 6 and 7](#), no defects in the FRP on the surfaces facing the ocean or on the opposite surfaces were found.

Figure 6: a column with some coating worn out on the side facing the sea due to the abrasive action of sea water with sand. The small yellow area shows the FRPs under the coating

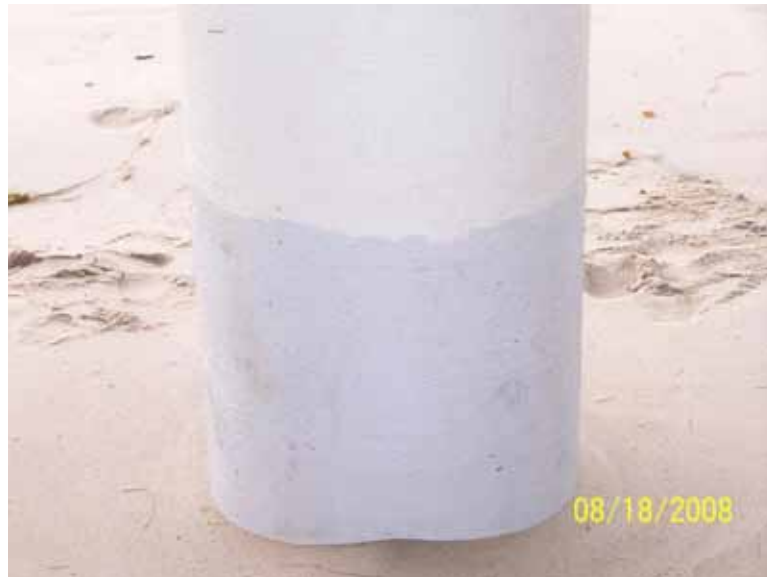
Figure 7: the opposite side of the column to the sea.

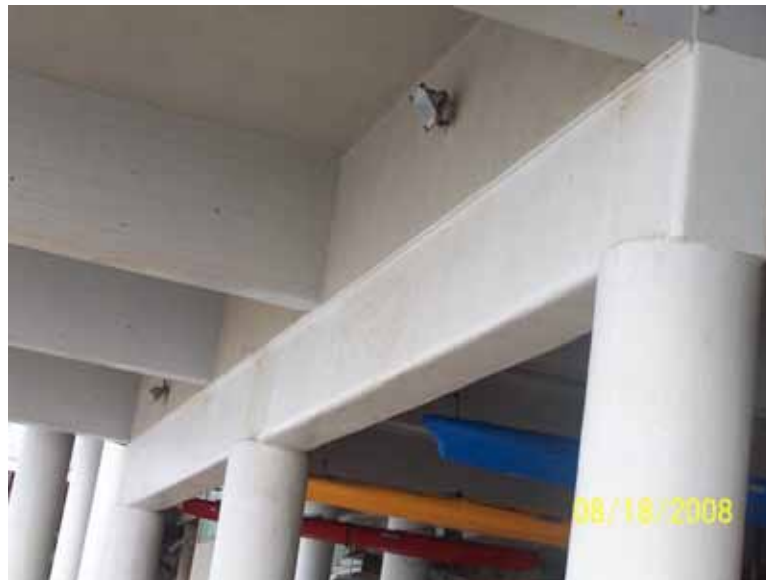
No cracks are visible on the joints between the column and the beam, as shown in [Figure 8](#). This indicates all columns effectively support the whole structure as originally designed. No column shows weakness or defects.

Figure 8: joints between the retrofitted column and the beam

Also in Figure 8, the retrofitted beam appears in perfect condition. No signs of debonding between FRP and the concrete substrate, cracks or abnormal deformation of the whole beam.

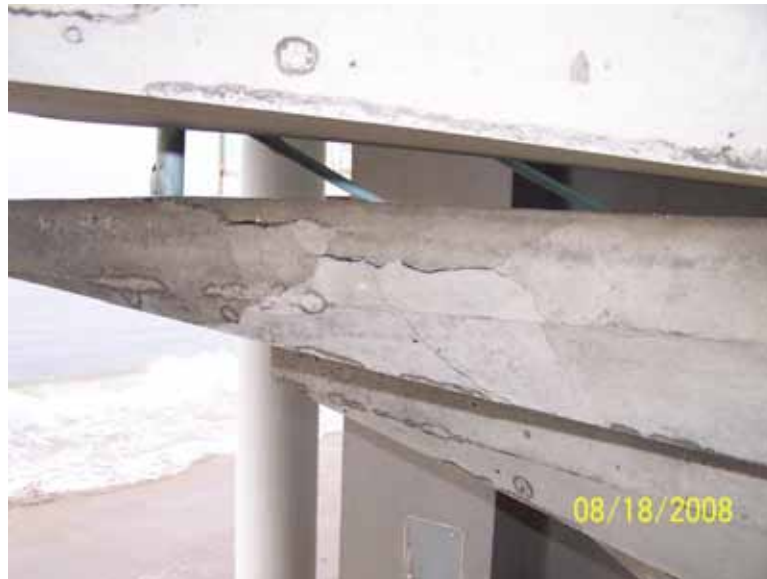
It is worthwhile to note the condition of the concrete steps of the same building that were not retrofitted with the Tyfo® Fibrwrap® Systems ([Figure 9](#)). It is remarkable to see the concrete cracks and concrete chalking, indicating the severity of the ASR effect.

As previously discussed, the occurrence of ASR is due to the concrete type (e.g., including high alkali cement and reactive aggregate) with sufficient water/moisture ingress. The concrete structures used for this building are expected to be the type for ASR. With sufficient water/moisture in the ocean front environment, it is not surprising to see the serious occurrence of ASR. As the ASR damaged concrete structures can be retrofitted and strengthened with the Tyfo[®] Fibrwrap[®] System, the concrete structure can perform in the harsh environments (for ASR this means high humidity or water immersion) with proven long-term durability. At the same time, due to the high water-proofing effect of the Tyfo[®] Fibrwrap[®] System, it is expected that it will be difficult for water to penetrate through the system into the concrete. Therefore, the ASR will be retarded significantly. As believed, the ASR caused expansion will lead to the cracks and/or irregular deformation on the column / beam surfaces. The lack of any cracks or irregular deformation formed on the retrofitted column / beam surfaces indicates the retarded or ceased ASR in the retrofitted structures.

Figure 9: Concrete steps in the same building. Note the back column was retrofitted with Tyfo[®] Fibrwrap[®] systems.
