Long-Term Performance of Tyfo[®] Fibrwrap[®] System

Nine-Year Inspection of Tyfo[®]
Fibrwrap[®] System Applied in a
Marine Environment

May 28, 2008

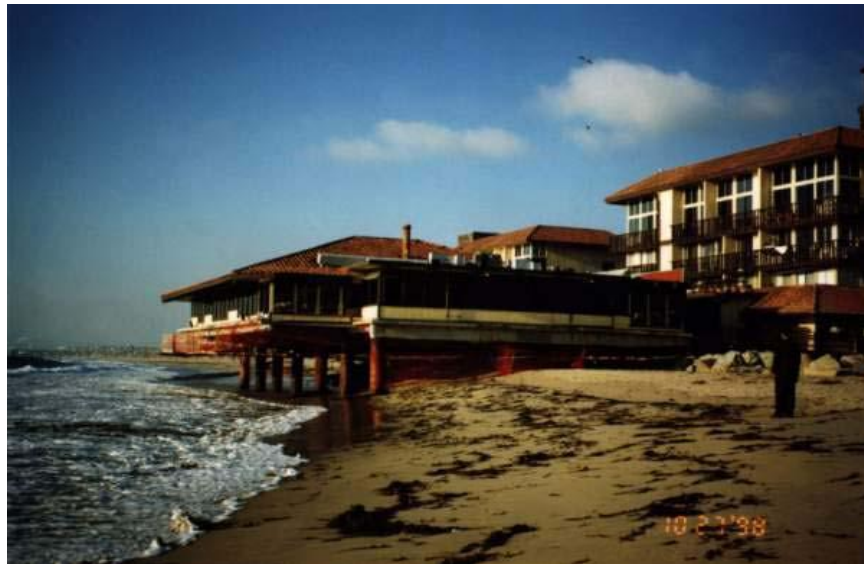
The upscale restaurant located in Redondo Beach, CA, USA, was in poor condition structurally and aesthetically mostly due to exposure to marine weather conditions, such as sea water immersion, ocean surf, high humidity and high winds etc. The actual situation of the restaurant can be seen in the pictures presented in Figure 1 and Figure 2, which were taken in 1998 before retrofit and strengthening. It was found that the slab, beams and pilings were severely deteriorated (Figure 2). Due to such poor conditions, the city required a permanent repair of corrosion damage to pilings, beams and slab or the restaurant would have to be demolished.

Figure 1: Un-repaired restaurant with poor conditions.

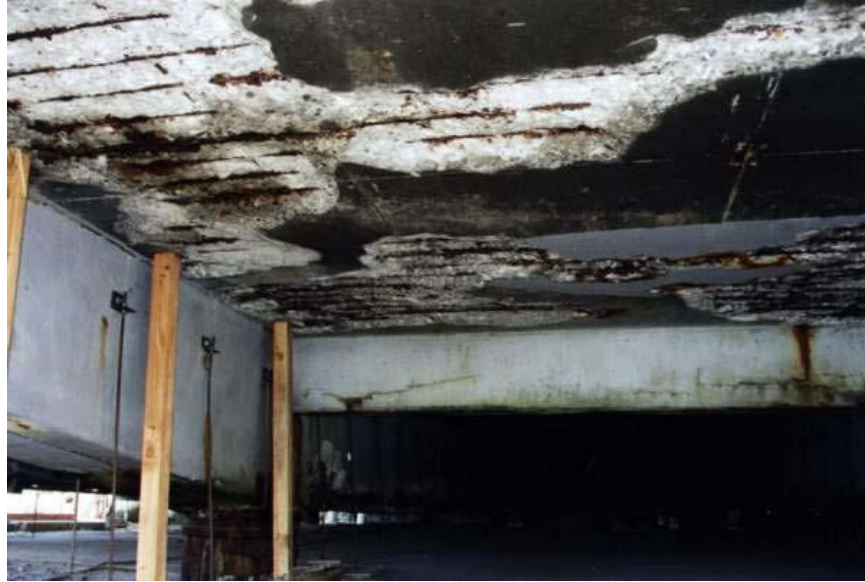
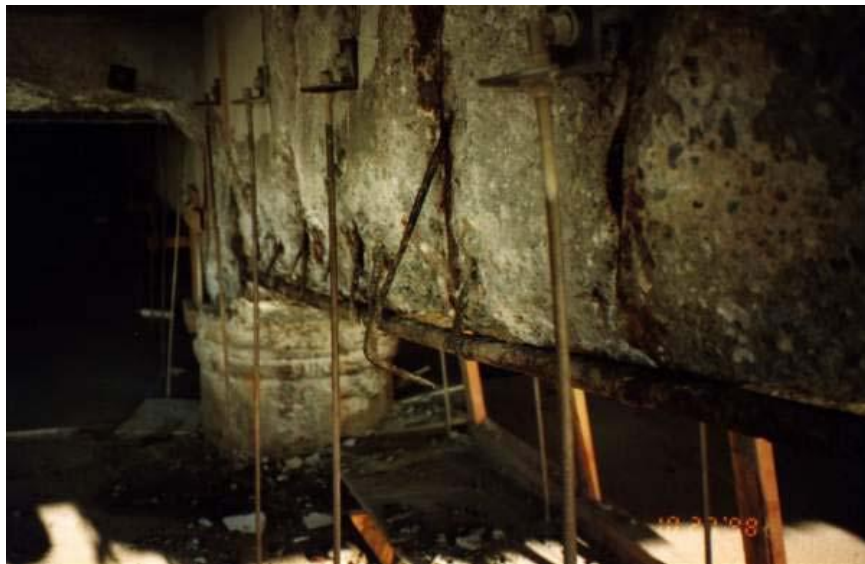
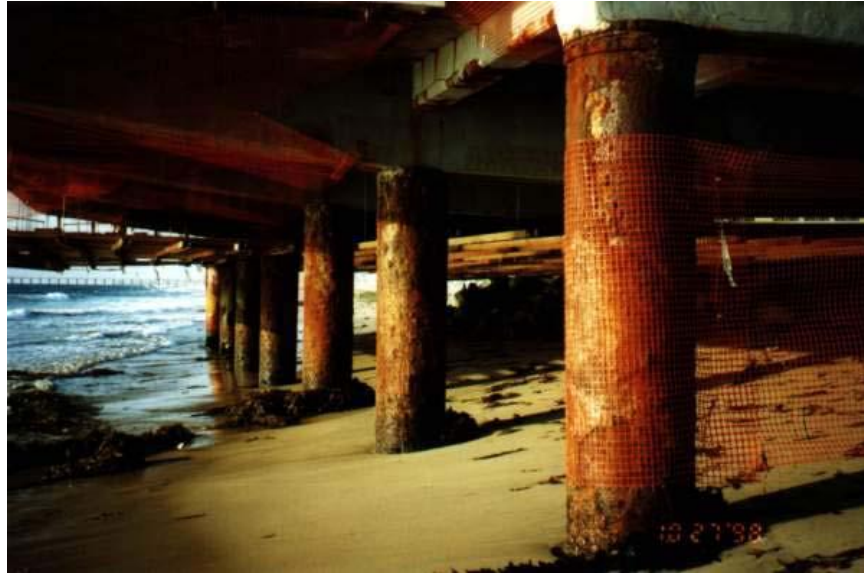
Figure 2: Corroded slab (a), beam (b) and pilings (c).

The deterioration of pilings, beams and slab required a phased retrofit, which would include the strengthening of specific areas and sealing the entire underside of the restaurant. To reach those requirements, the Tyfo® Fibrwrap® System was selected as the long-term solution. A process of discovery was initiated to remove unsound concrete. After treatment with a corrosive inhibitor system (Tyfo® CIS), the exposed steel and surrounding concrete was sandblasted. Polymer-modified concrete was then applied to reform members to their original shape. The Tyfo® SEH glass and SCH carbon systems

were applied to strengthen the structures. A final application of Tyfo® WEB and Tyfo® U finish were used as a water sealant and protection from the harsh environment.

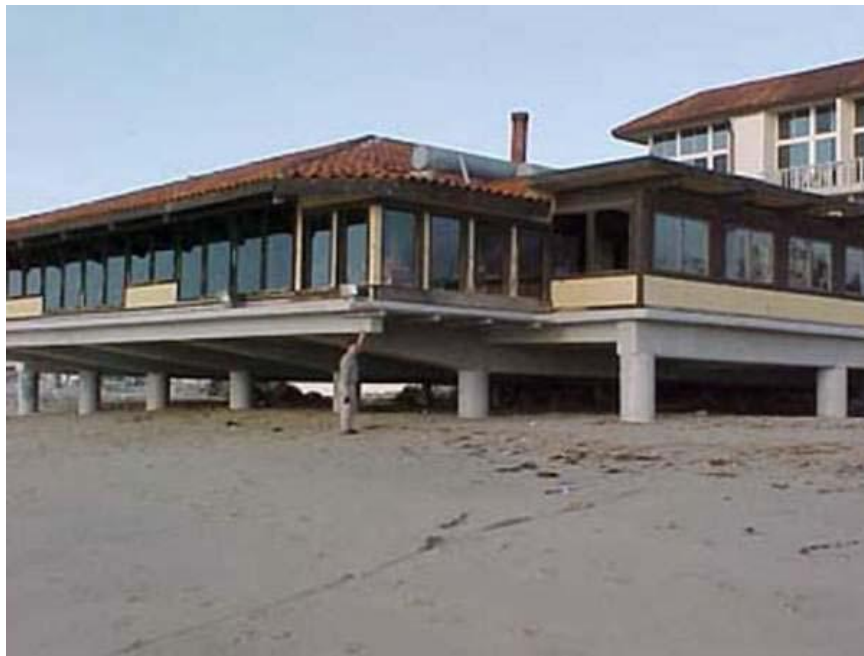
The project was finished in May 1999. The photograph in Figure 3 shows the restaurant just repaired with the Tyfo® Fibrwrap® System.

Figure 3: Photograph of the just repaired restaurant in 1999.

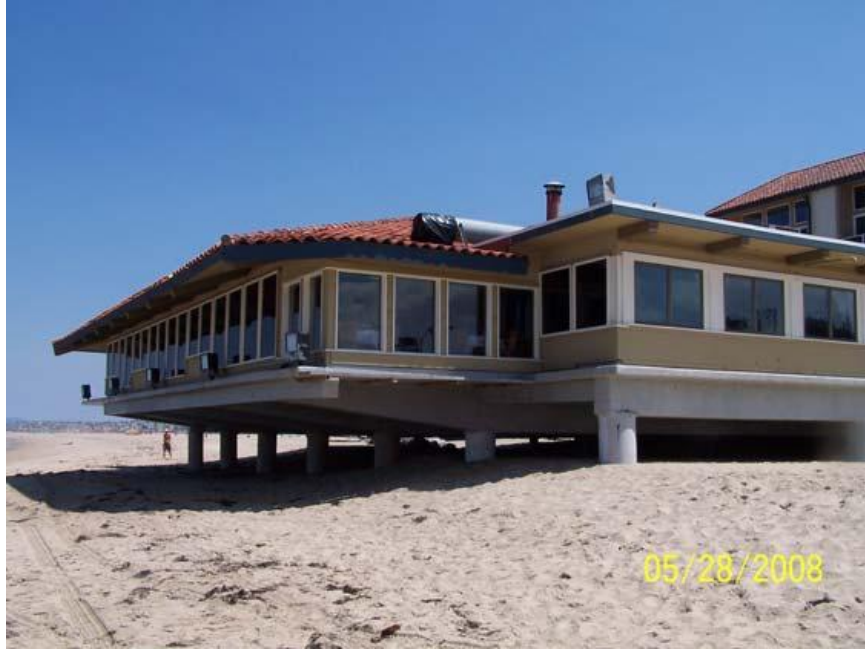
Figure 4: The restaurant on May 28, 2008

The photograph of the current restaurant is shown in Figure 4, which was taken in a similar direction as compared to the photograph in Figure 3 (just after installation). As shown, after nine years service, the repaired elements are sound and in good condition. It should be noted the black mark on the first piling is due to containment of petroleum rather than cracking. The containment is assumed to be coming from sea water surge, and is also found on the slab and beams of this building.

However, there are two pilings, which show a short, narrow and shallow crack in the FRP (fiber reinforced polymer) along the joint line between the beam and the piling. One is

the first piling from the right in Figure 4 and the other is immediately next to this one on its right side, which is not shown in the photo. It is worth noting that both pilings are facing the west direction. The crack may come from the high temperature rise in the daytime, due to the strong sun exposure in the afternoon. Those slight cracks are not expected to cause deterioration of the reinforcement of the Tyfo® Fibrwrap® System.

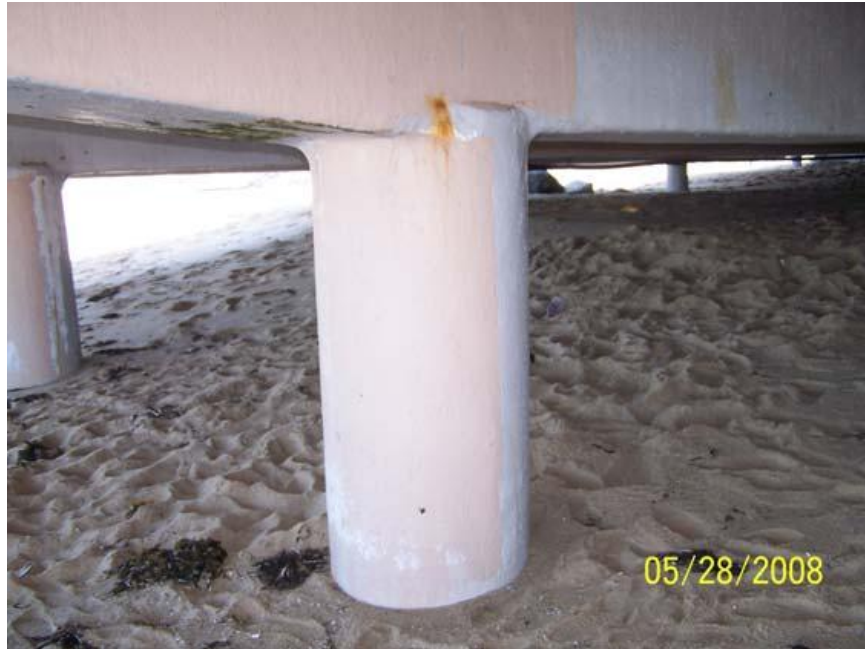
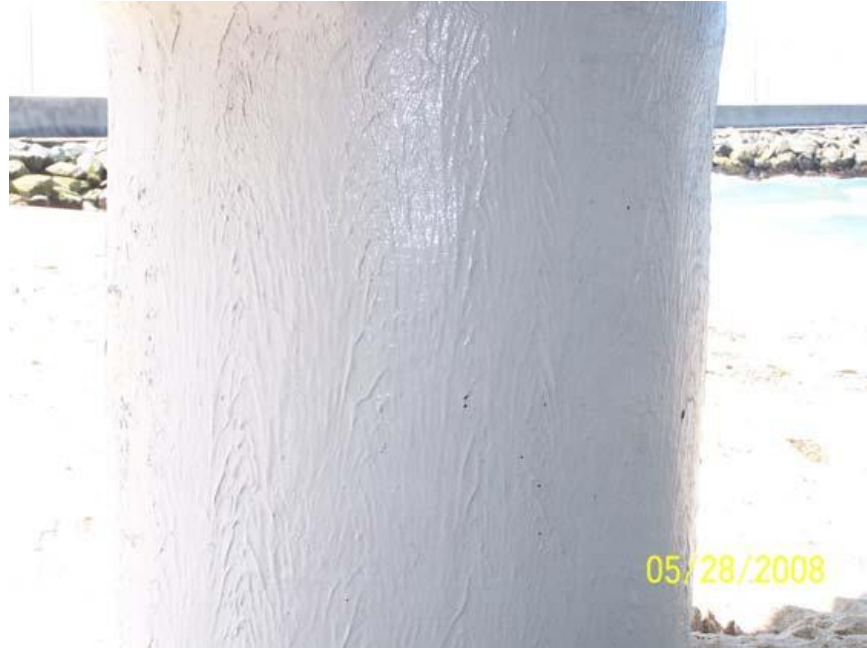
2.1 Pilings: All pilings exhibit perfect conditions. No delamination, blister or significant defects were found. As shown in Figure 5, no defects on the surfaces, facing the ocean or on the opposite surfaces, were found.

Figure 5: Photograph of piling. a) the side facing the ocean and b) the back side.

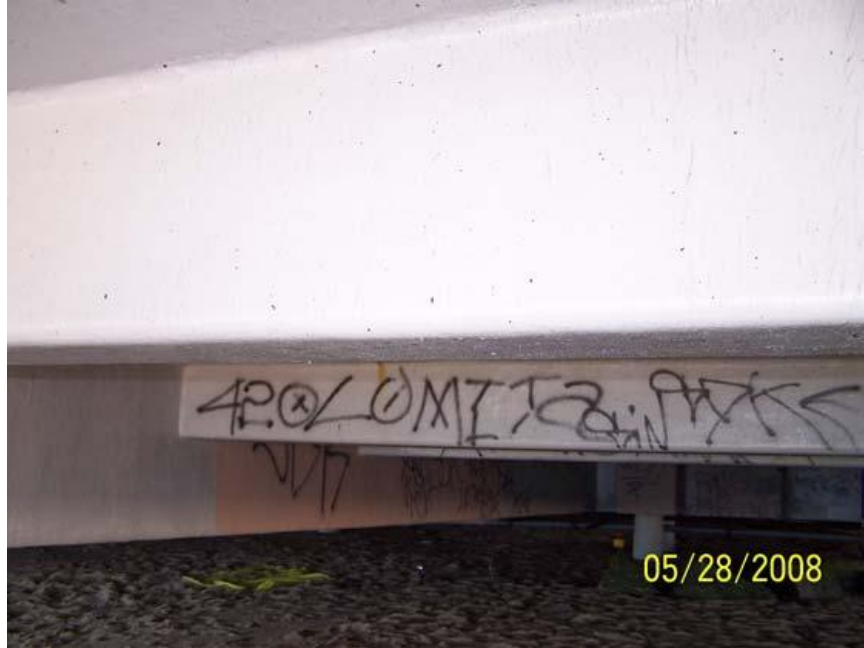
2.2 Beams: No signs of significant failures, such as delamination of FRPs from the concrete, cracks etc. were found on any beams (Figure 6). However, on some regions, coating was peeling off from the FRP (Figure 7). Since most surfaces (facing the ocean or on the opposite side) do not have such problem, the peeling off of the coating may be due to the installation process. For example, the coating may have been applied on the wet FRP surface, leading to a poor adhesion. In such a high humidity environment, it is not surprising to have such problems. As shown in Figure 8, the surface of the beam is covered with a layer of sea water with droplets, which is taken at 10 a.m. on a sunny day.

Figure 6: No signs of defect on the beam.

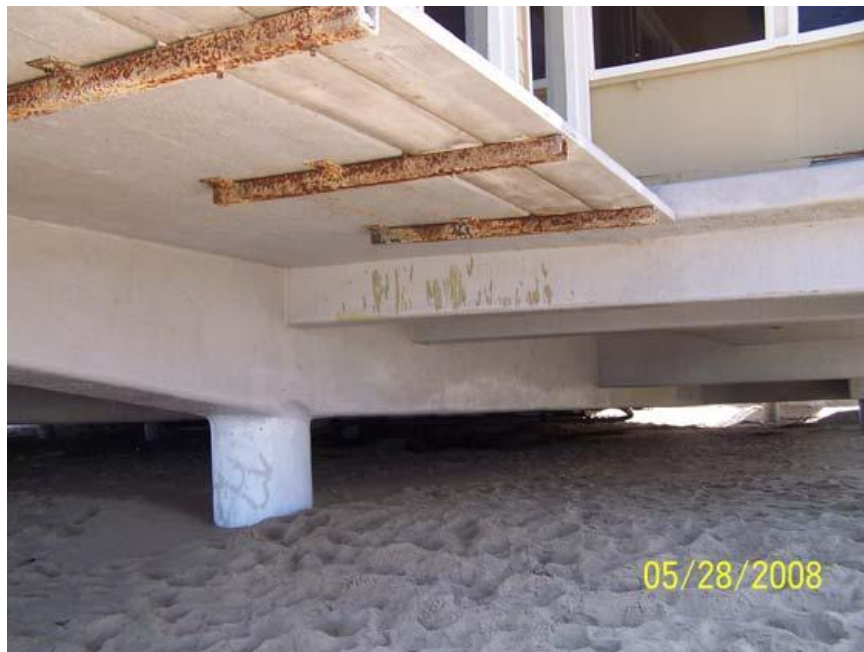
Figure 7: Some paint peeling from FRP on the beam.

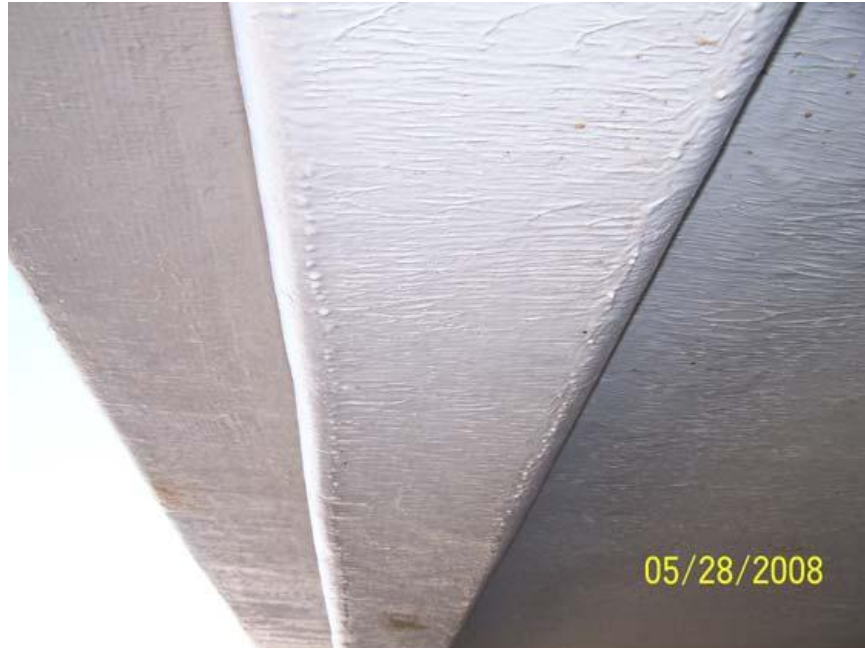
Figure 8: Water droplets formed on the beam. Picture was taken at 10 am., May 28, 2008.

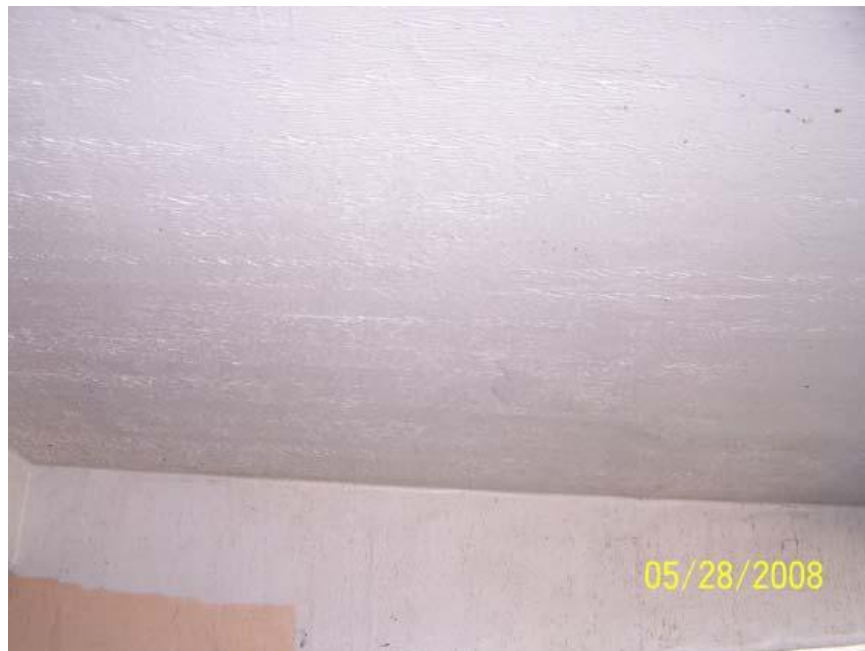
2.3 Slab: Similar to the beams, no significant defects were found on the slab (Figure 9). Most parts of the slab look perfect. However, there are some areas which also show peeling off of the coatings. As believed, the mechanisms are the same as the case for the beam.

Figure 9: Repaired slab without defects after 9-year of services
