Project Brief

Castlewood Canyon Bridge

Arch & Beam Strengthening

Colorado, USA
Fall 2003

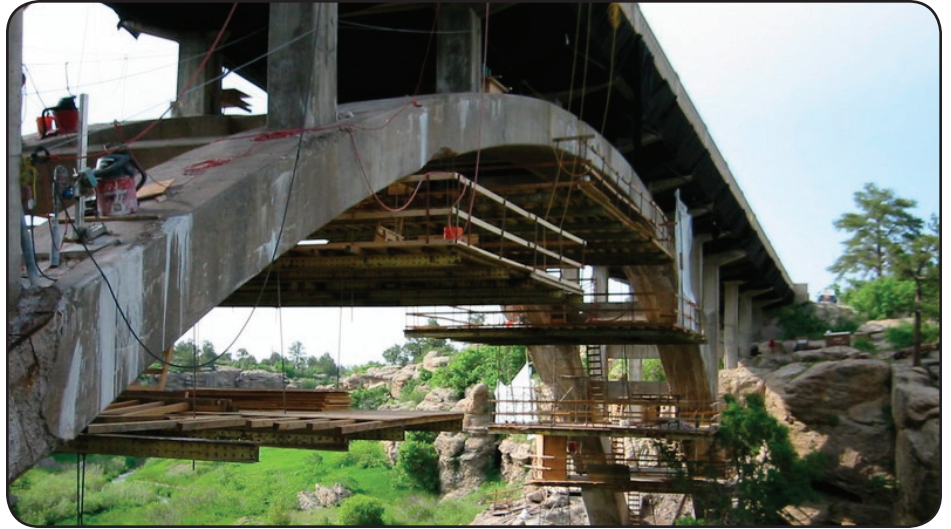
For more than 50 years the Castlewood Canyon Bridge has suffered general concrete spalling, degradation, and corrosion of reinforcement steel. Therefore, Tyfo® SCH composites (carbon composite) were used to supplement strength lost in the arch in both the longitudinal and transverse directions while the link beams were strengthened for shear.
