Project Brief

GAF Materials Pedestal Structural Strengthening

Michigan City, IN
December 2006

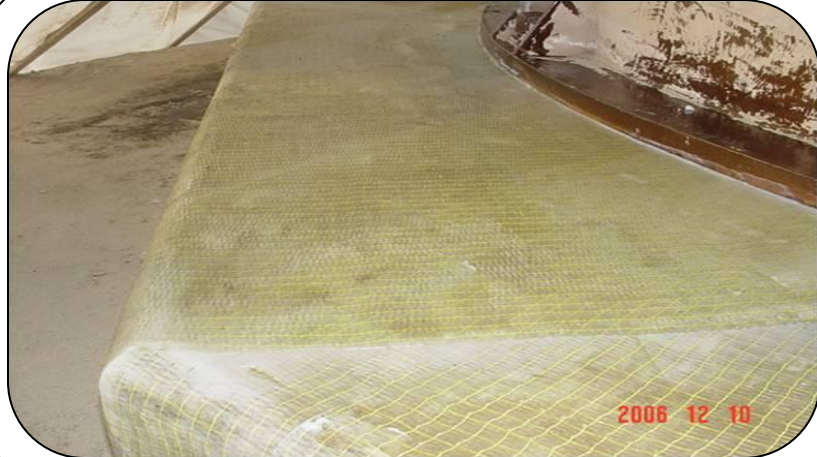
A study of the condition of the oxidizer tank foundations at GAF Materials Corporation in Indiana indicated a lot of distress in the concrete piers on which the tanks were sitting. The deterioration of the concrete was attributed to the thermal shock of the hot water off the oxidizers. During the quenching stage and during winter, the freeze/thaw impact directly affected the concrete.

The repair scheme consisted of three phases: 1) injection of all cracks in the pier foundations using Tyfo® 111 low viscosity epoxy; 2) concrete surface repairs using an epoxy grout; and, 3) the installation of two layers of the Tyfo® SEH-51A System (glass composite). The first layer of the composite system was applied perpendicular to the octagonal edge, the second layer horizontally around the pier. Upon completion an anti-slip industrial paint was applied.

This was a temporary fix until a more permanent solution could be developed. The environment was very hostile and the solution using Fibrwrap® was a good one to allow the tanks to be used until a more thorough investigation could be completed.
