Project Brief

## Janesville Tank Structural Strengthening

Janesville, MN  
August 2008

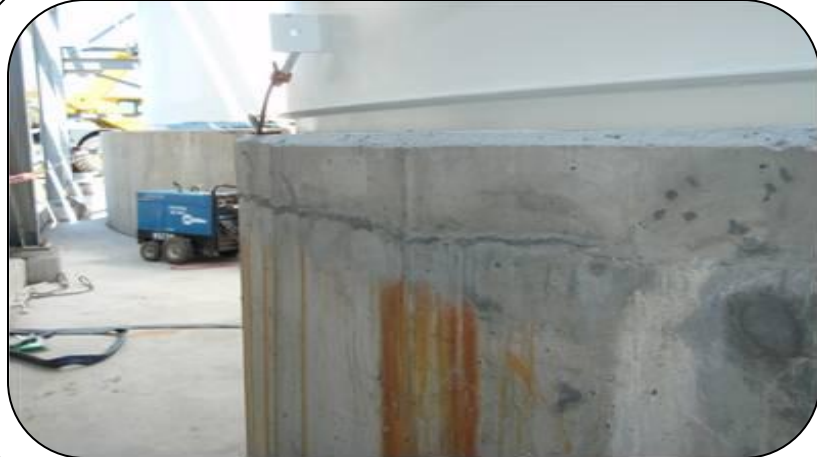
During the construction of the new ethanol plant, a crack was discovered in the concrete base of one of the processing tanks. The foundation was 20 feet in diameter. The design called for an embedded steel channel in the concrete to which the steel tank would be welded. During the welding process, the expansion of the steel caused a crack in the concrete. The second tank did not suffer the same problem as the edge distance was much greater between the channel and the edge of the base.

The engineer wanted to arrest the crack and wanted to confine it after the crack was repaired. The GC repaired the crack with a cementitious product. Then a layer of glass fiber was applied around the base covering the top 24 inches of the base.
