Project Brief

## KDOT Column Column Strengthening

Kansas  
August 2005

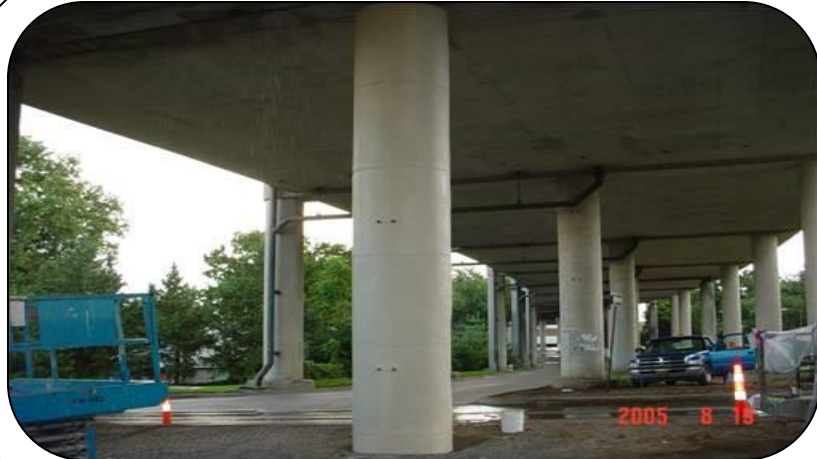
Columns showed extensive concrete deterioration due to exposure to the elements.

Concrete was repaired and restored on several column locations prior to the installation of Tyfo® SEH 25A. Gaps were left for water drainage, per the specifications.

The installation of Tyfo® Fibrwrap® over concrete repairs is an ideal long-term solution for protection of the repair area. The fiber wrap seals the area and eliminates the possibility of further corrosion. Using the Tyfo® CIS corrosion inhibitor product is another step that increases the longevity of the repair.
