Project Brief

Koch Flare Pipe Retrofit

Texas, USA

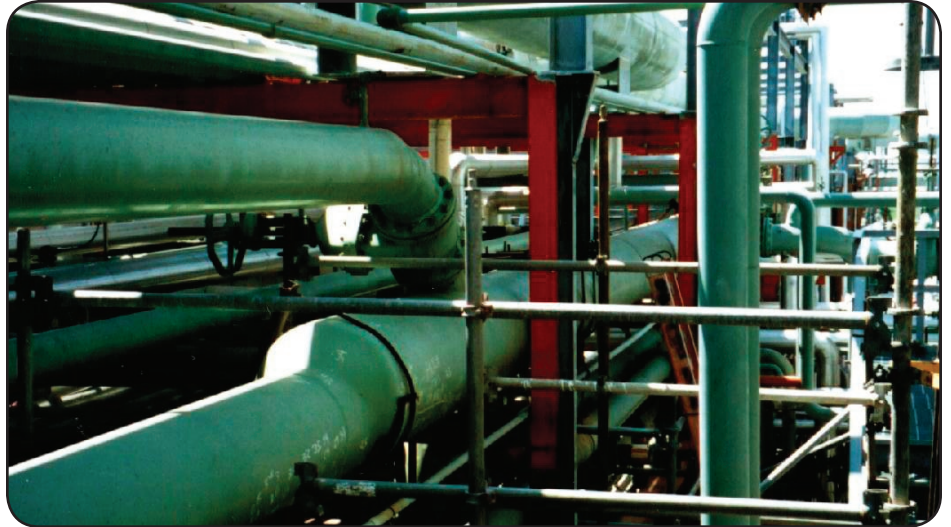
A test precluded the installation to determine if the Tyfo® System could withstand high temperatures and pressure. Corrosion damage was heavy on the underside of the pipe and the need for temporary, conventional patching was required prior to the installation to contain the flare contents. This application was experimental and has great potential. Specific installation procedures were in place to ensure a successful application. A final layer of UV-resistant paint and Tyfo® FC/F fire protective coating was applied to ensure safety and long-term performance.
