Project Brief

## Bama Company

### Steel Deck Repair

Tulsa, OK  
2003

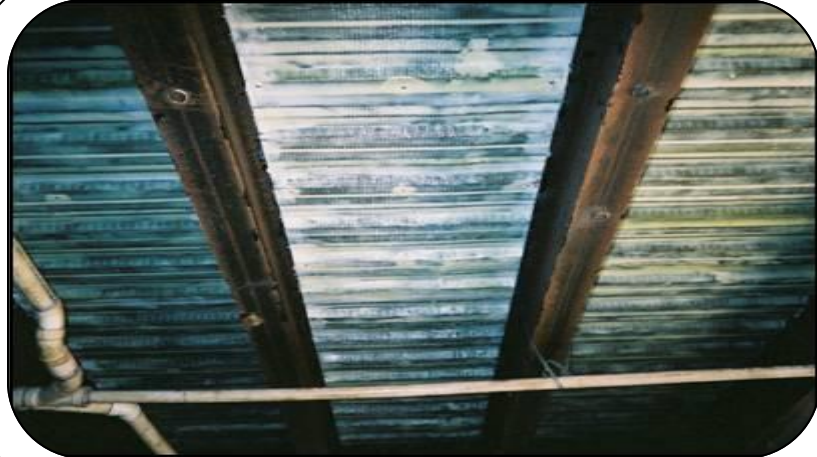
The steel deck of the floor system at the industrial facility showed signs of heavy corrosion. The steel deck was designed compositely with a concrete slab above and the structural integrity of the floor system was in question.

The fiberglass-based Tyfo® SEH-51 Composite System provided the tensile strength of the floor system in lieu of the deteriorated steel deck. The deck was sandblasted and cleaned thoroughly prior to the installation of the composite system. The composite was adhered to the steel deck with the Tyfo® S high-strength epoxy and additionally anchored with Hilti® pins with enlarged washers. The Hilti® pins also enabled the Tyfo® System to act compositely with the concrete slab above to create a strengthened, non-corrosive floor system.
