Project Brief

Chula Vista Bayside Park Pier Pier Rehabilitation

San Diego, CA
2009

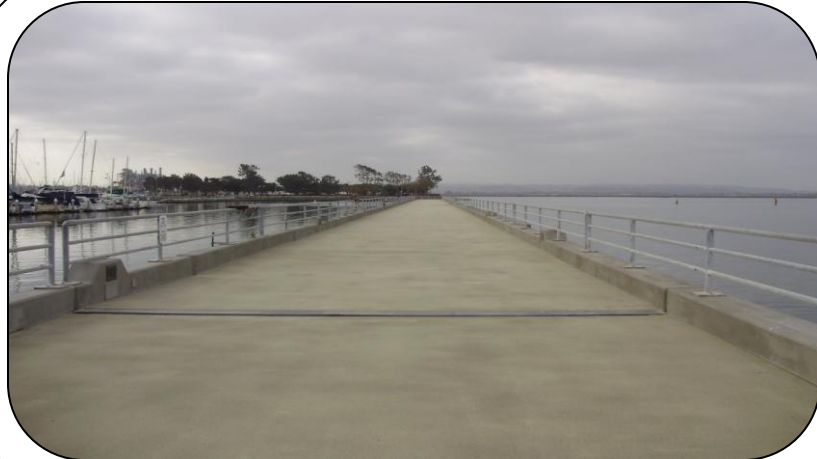
The Chula Vista Bayside Park Pier required a full rehabilitation of the entire deck, beams, and piles suffering from spalled and deteriorated concrete and corroded steel.

The deck, under-deck, beams, and piles were repaired by removing unsound concrete, treating and replacing severely deteriorated rebar, and patching back with a polymer-modified cement mortar.

The Tyfo® SCH-41 System was utilized on the piles both in the longitudinal and transverse direction to supplement for the corroded steel and provide adequate confinement. Although the piles were subject to constant wetting from tide fluctuations, Fibrwrap® Construction was able to develop a flexible schedule, work around acceptable tide conditions, and finish the project in a timely and effective manner.
