Project Brief

Darnley Bridge

Wood Pile Shear Strengthening and Protection

Eastern Canada
2005

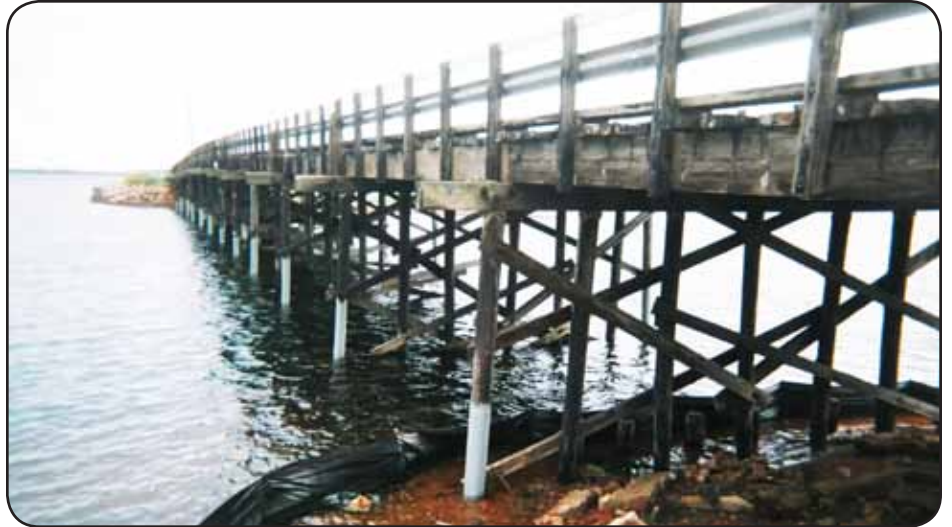
Shear strengthening, repair and protection of damaged wood pile piers for existing bridges in Eastern Canada.

Ice shear forces, scouring of ice, and aging caused shear and necking problems for the existing woodpiles, mainly in the tidal zone.

Repair of piles by filling with cementitious materials, where necessary, then wrapping the piles with Tyfo® SEH-51A/SW1-S composite system for shear strengthening and protection of existing piles from ice forces.

Compared to existing repairs using conventional materials, the repair was less costly, faster, more aesthetically appealing, and durable.
