Project Brief

Dominion Pipe Strengthening

Yorktown, VA, USA
October 2002

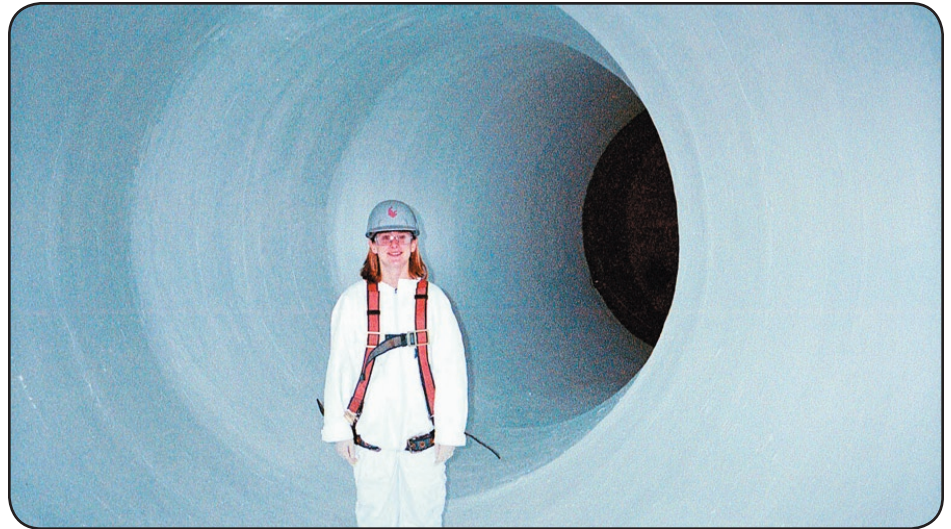
The Tyfo® Fibrwrap® System was used to strengthen and rehabilitate this large diameter steel pipe.

The 120" diameter steel pipe at this power plant was severely rusted due to the corrosive environment. A repair solution was needed that could withstand the harsh environment and be installed with minimal shut down time at the plant.

A repair solution was designed using The Tyfo® Fibrwrap® System. One layer of the Tyfo® SEH Glass Composite System was installed longitudinally in the pipe. This was followed by one layer of the Tyfo® SCH Carbon composite system. The glass composite provided strength in the longitudinal direction as well as acting as a dielectric barrier between the steel and the carbon fibers. Small crews certified to work in confined spaces installed the composite materials during regularly scheduled shut down times. A unique scaffolding system was designed to allow access to all sides of the pipe at one time. This ensured that the circumferential layer of the composite could be applied continuously around the pipe.

The FRP Composite Solution to this pipe deterioration provided a quick repair technique to repair the deteriorated steel. There was minimal impact on the power plant operations and the solution will hold up well in this aggressive environment.
