Project Brief

Hwy 35 and 169 Bridge Girder Repair

Twin Cities, MN
2004

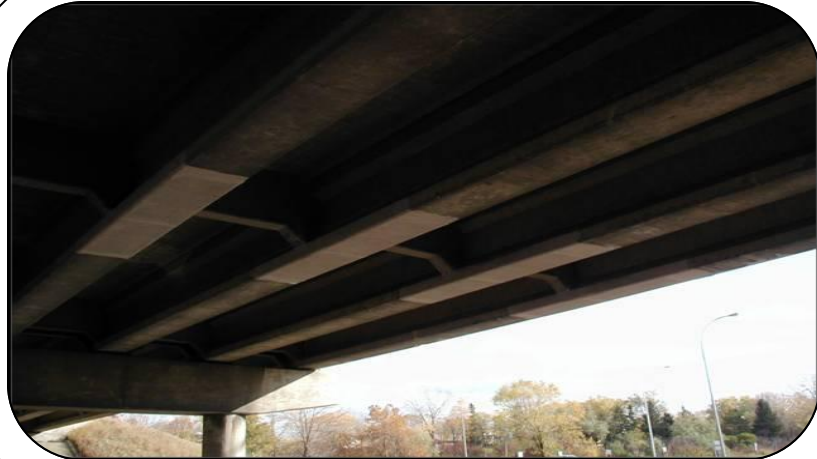
Two bridges were damaged due to impact by truck payloads in separate incidences. In both cases, the pre-stressed concrete girders attained minimal structural damage. However, the existing pre-stressing strands showed evidence of corrosion due to the exposure from the loss of concrete attained from impact.

The girders required corrosion treatment, coupled with patching, using the Tyfo® P Epoxy Mortar to restore the girder section. The patched areas were then wrapped with the glass-based Tyfo® SEH-51 Composite System. The composite was utilized as a “structural band-aid” over the overhead patched areas.
