Project Brief

Italian Autostrada (Highway Dept.) Highway Tunnel Repair

Italy
2004

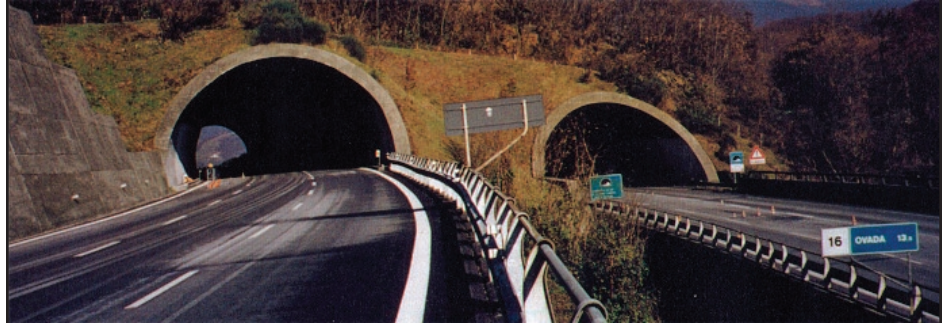
Two 100-meter long tunnels.

Both tunnels had severely cracked concrete caused by the earth moving above the tunnel. This led to considerable water damage.

Two layers of Tyfo® WEB were applied to prevent the cracks from growing. Tyfo® Fibrwrap® Anchors were installed to increase bond strength. In addition, drainage channels were cut every 3 meters or so to allow the water to drain to the ground and flow out. A finish coat of Tyfo® FC/F was applied.
