Project Brief

**Malibu Residence**  
**Concrete Repair & Preservation**

Malibu, CA, USA  
September 2001

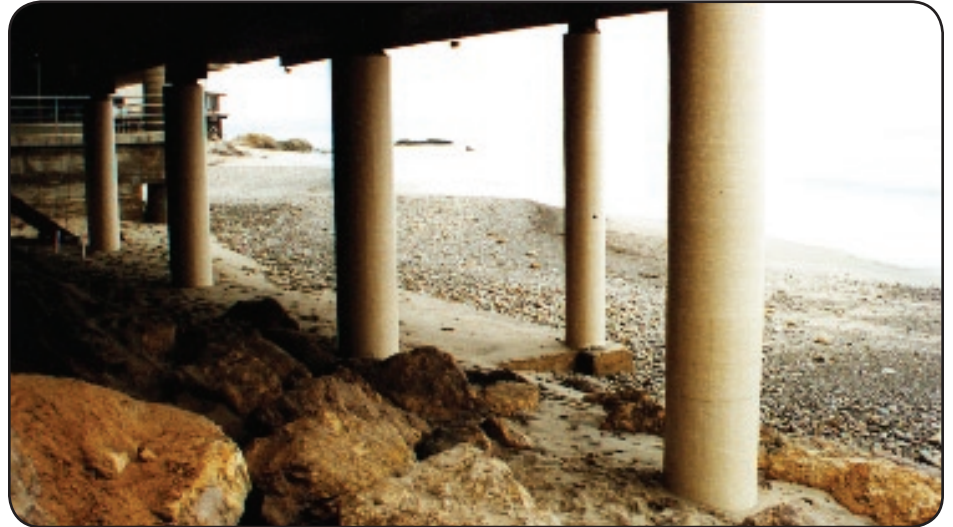
Located in Malibu, California the ocean front residence had been pounded by the surf over the years. The owner was becoming more concerned with further damage to the supporting columns and beams.

The supporting girders and beams had suffered severe corrosion due to the aggressive marine environment. Columns suffered moderate to tenuous cracks and general concrete spalling.

First, all loose and damaged concrete was removed and then steel reinforcement lost to corrosion was estimated. Next, the Tyfo® CIS corrosion inhibitor was applied to all exposed steel and then the Tyfo® concrete repair products were used to patch the absent concrete and preserve. After estimating the steel reinforcement lost to corrosion Fyfe Co. engineers designed the Tyfo® laminates to add the necessary reinforcement in flexural, shear, and confinement deficiencies. Finally, the Tyfo® Systems were coated with a thickened epoxy coating to protect them from the abrasive nature of ocean tides and sand.
