Project Brief

## Miramar Water Treatment Plant Clearwell 2 Column, Beam & Corbel Repair

San Diego, CA, USA  
January 2003

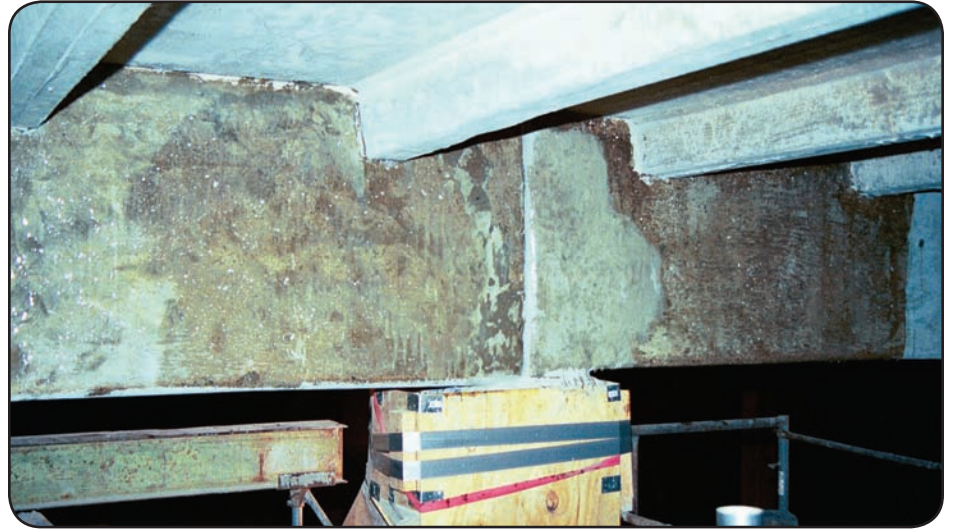
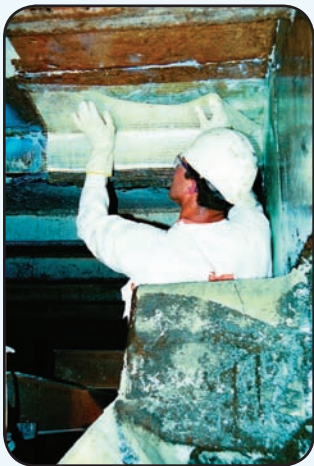
Miramar Water Treatment Plant Clearwell No. 2 built in the early 1960's was suffering from general degradation of structural elements.

The majority of the columns, beams, and corbels suffered from moderate corrosion problems coupled with concrete spalling.

Fyfe Co. LLC developed several innovative solutions to handle each challenge. Some solutions included wrapping columns, confining corbels, building beam-struts at the base of columns, and applying the Tyfo® System to the underside of beams for additional flexural capacity.
