Project Brief

Natural History Museum

Cold Joint Shear Transfer

Los Angeles, CA
2009

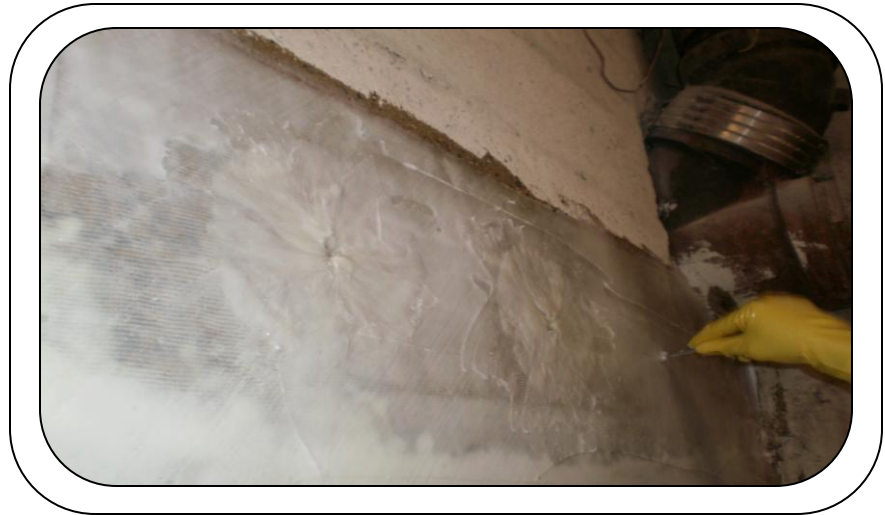
The Natural History Museum in Los Angeles County displayed a wall without adequate rebar where a cold joint occurred, requiring added shear capacity.

The glass-based Tyfo® BC System, oriented in the $\pm 45^\circ$ direction, was installed above and below the subject cold joint to provide the required strengthening. Tyfo® SEH Fibr™ Anchors were also placed above the cold joint due to the poor condition of the existing concrete wall.

With the versatility of the Tyfo® Fibrwrap® Systems, the design of the fiber was able to work around existing conduits and openings that otherwise would have required movement and replacement.
