Project Brief

Redondo Beach Restaurant

Repair and Retrofit of Corroded Beams, Slabs & Columns

Redondo Beach, CA, USA
May 1999

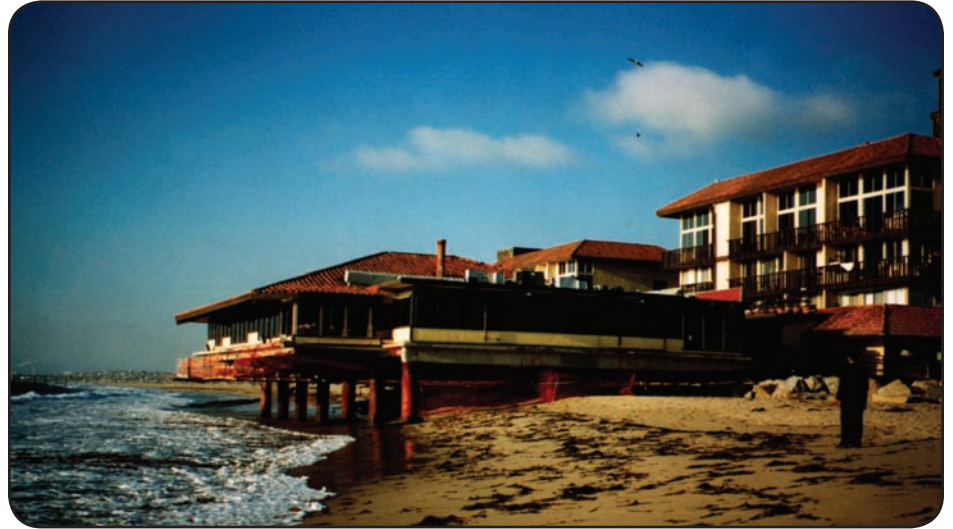
An upscale restaurant and adjoining apartment complex, which was in poor condition structurally and aesthetically mostly due to exposure to marine weather conditions. The restaurant actually sets out into the ocean on concrete pilings and ocean surf is continually surging up against the bottom of the restaurant's floor. The city required a permanent repair of corrosion damage to pilings, beams and slab or the restaurant would have to be demolished.

The severe deterioration of pilings, beams and slab required a phased retrofit, which would include the strengthening of specific areas and sealing the entire underside of the restaurant.

A suspended platform was constructed to provide working space for the crew, and at the same time, protect the beams and slab from the ocean surge. A process of discovery was initiated to remove unsound concrete. After treatment with a corrosive inhibitor system, the exposed steel and surrounding concrete was sandblasted. Polymer-modified concrete was then applied to reform members to their original shape. The Tyfo® SEH glass and SCH carbon Systems were applied to strengthen the pilings, beams and slab. A final application of Tyfo® WEB was applied as a water sealant and protection from the environment.
