Project Brief

South Coast Water District Concrete Repair and Column Strengthening

Long Beach, CA
2009

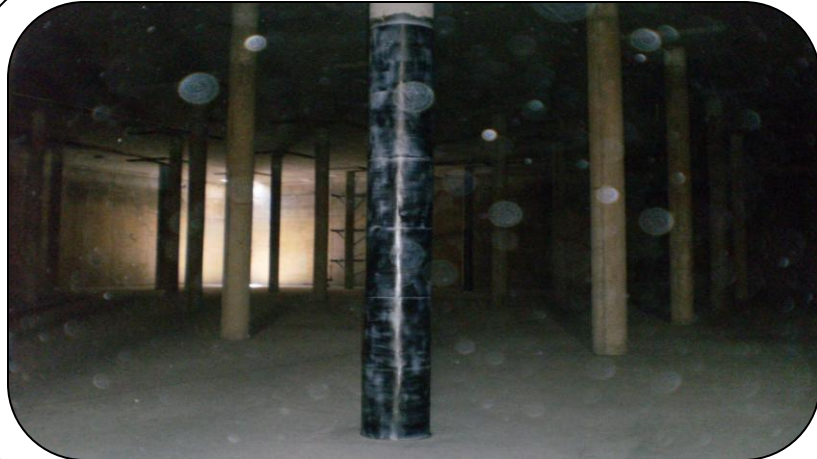
Several reinforced concrete columns in an underground water tank at the South Coast Water Reservoir suffered from corroded confinement steel and demonstrated spalled concrete due to inadequate concrete cover and water exposure.

The Tyfo® Concrete Repair System was used to repair and re-patch the loose unsound concrete with a new polymer modified cement mortar, and to also treat the corroded steel with a corrosion inhibitor. Two layers of the carbon-based Tyfo® SCH-41 System were then applied to provide an equivalency to the corroded steel, restoring the columns back to their original design capacity and also serving as protection from future corrosion.
