Project Brief

UCR Culver Arts Center Wall Strengthening

Riverside, CA
2008

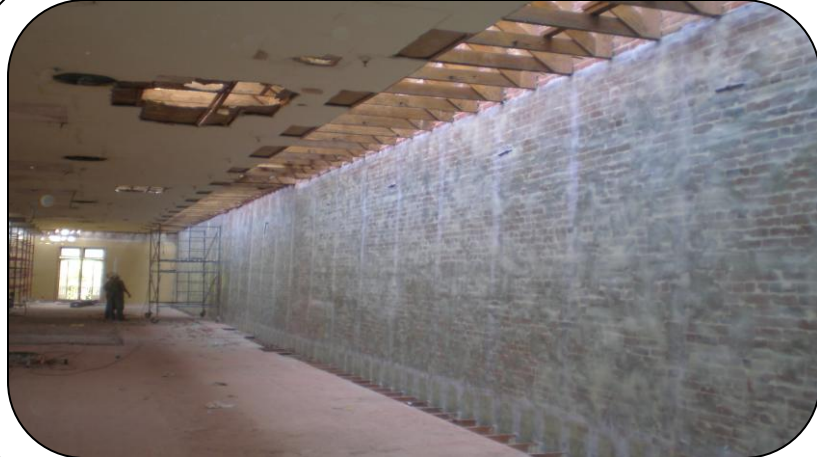
A URM and partial concrete wall section at the Culver Center of Arts in UC Riverside required additional shear strengthening due to corroded reinforcing steel and spalled concrete.

Fibrwrap Construction, Inc. applied a concrete repair mortar to address the spalled concrete as well as the significant change in surface plane from the URM to concrete wall at a 6:1 ratio to smooth out the transition.

The glass-based Tyfo® SEH-51A was then installed both in the horizontal and vertical direction to provide the adequate required reinforcing as determined by Saiful Bouquet Structural Engineers.

The Tyfo® RR material was applied as a finish, providing a Class 1 Flame and Smoke rating.
